Environmental cost of flooding

A report by URBED (Urbanism Environment and Design) Ltd as part of the Big Lottery funded 'Rebuilding Together' project in Cumbria.

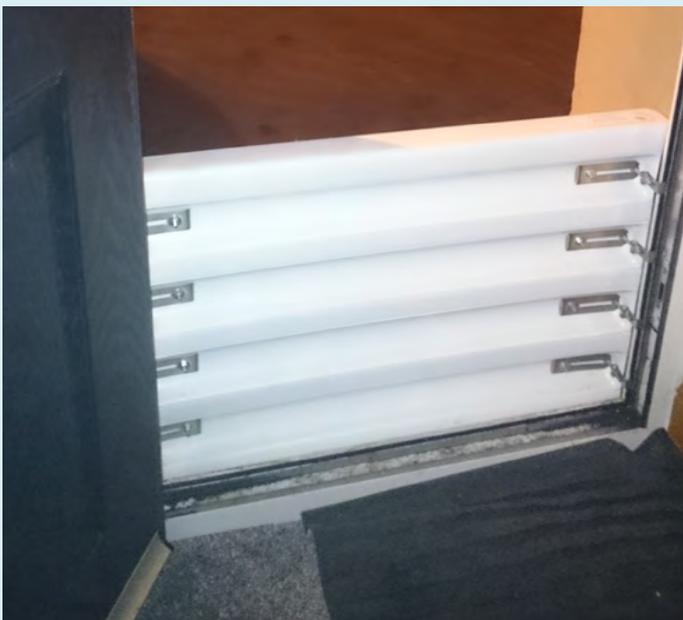
Above: flood doors fitted by previous owner

In the event, the flood gates offered little protection, as water found its way through cracks in the wall and other routes and eventually over-topped them. One of the flood gates (to the most critical rear elevation) appeared to fail as it had been badly fitted. The house has solid floors, so water coming up through the floor was not a factor.

This was the first time this householder had experienced a flood event, though they were aware of the risk due to previous events in the same area. The house had been fitted with flood gates (to front and back doors) by the previous owner, but little other work had been undertaken to their knowledge.

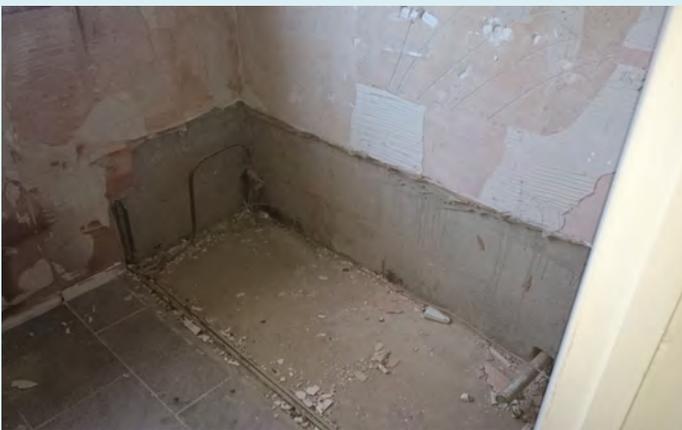
Above: the stripped out bathroom

Despite being fully tiled, the householder felt the walls in the bathroom had to be stripped as they were sodden and unable to dry otherwise. The bath, WC and hand-basin were all stripped out. Although the insurer argued the hand-basin might have been saved, the householder was able to argue for its replacement, and took these out themselves. The fitted kitchen was completely removed (chipboard based), and again taken to the HWRC by the householder.

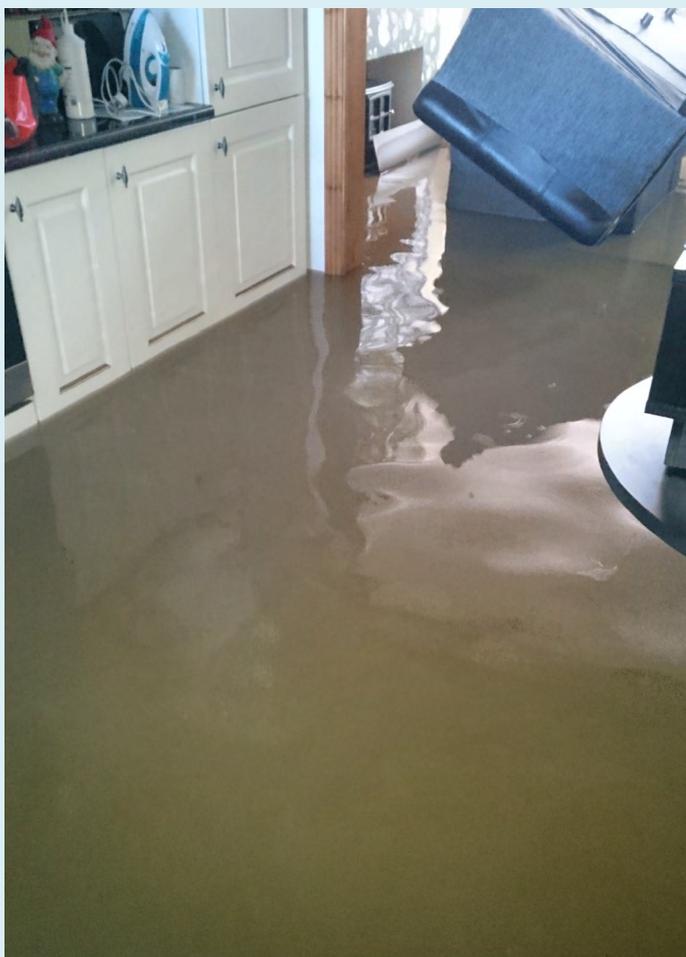
Flooding badly affected the kitchen and bathroom. The householder tried to move items like sofas above the flood water.

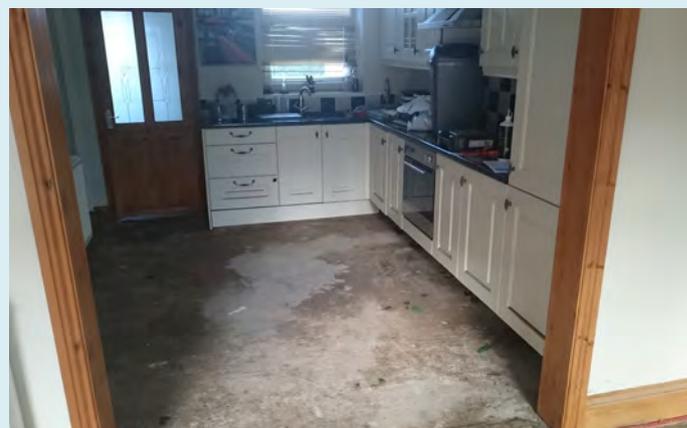
Tiles in the kitchen floor were stripped out and replaced.

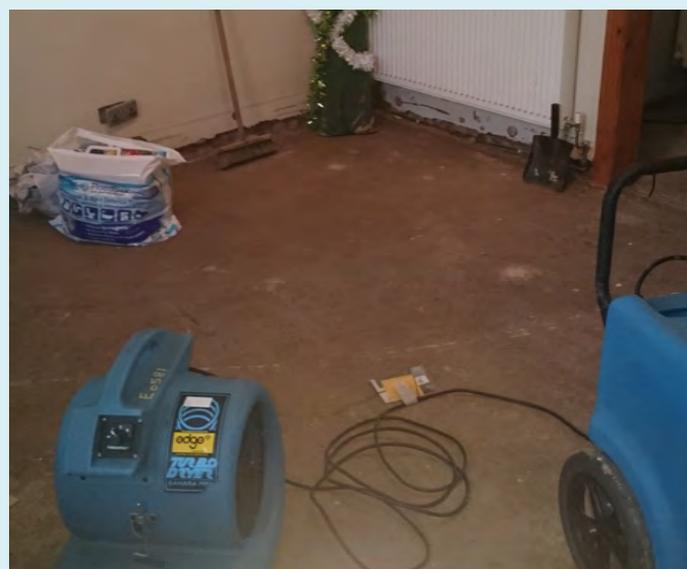
Drying out was by electric heaters and dehumidifiers.

Drying out was undertaken with electric heaters and electrically powered dehumidifiers, supplied by the contractor. The process took around a month and used a

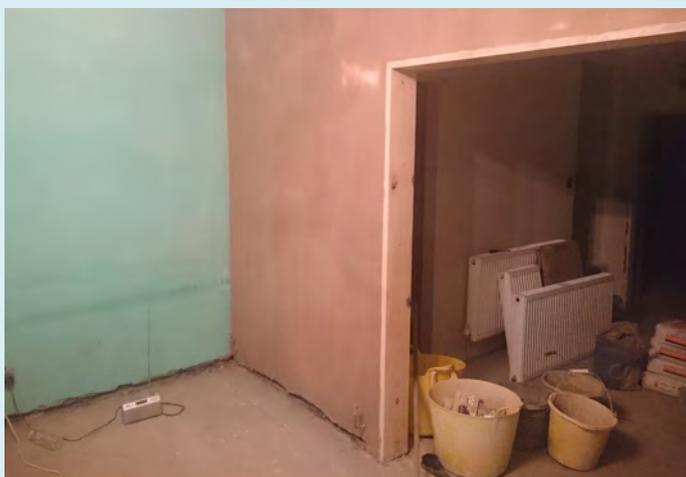
Re-plastering in the living room.

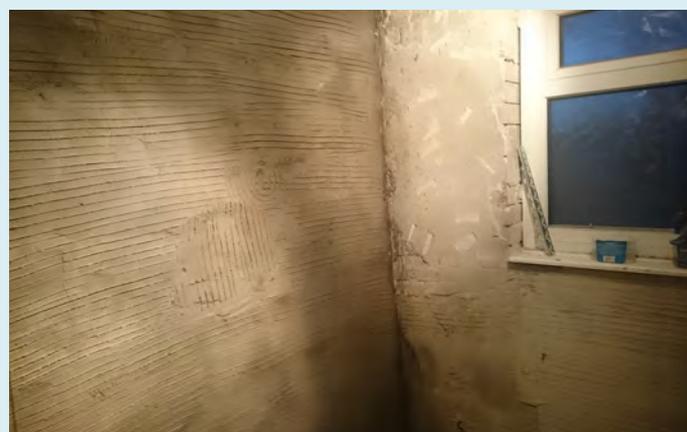
Bathroom tiles were also removed and replaced.

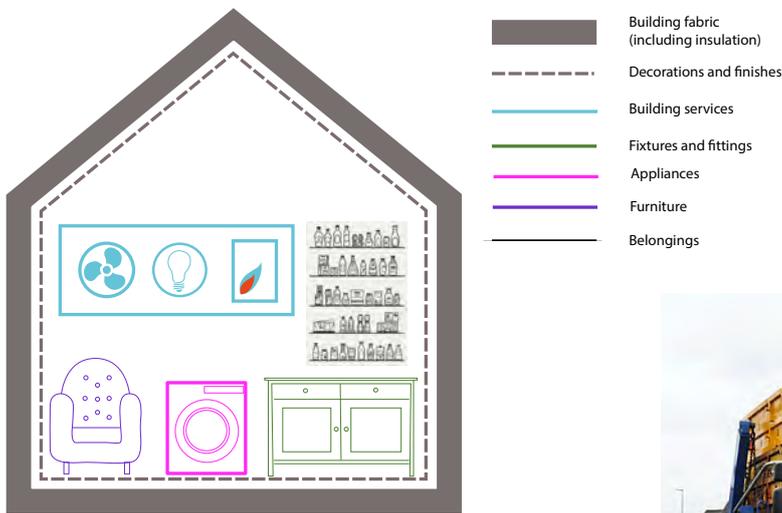
Above: Any home contains layers or construction and materials, all of which behave differently and need to be treated differently in any flood recovery process.

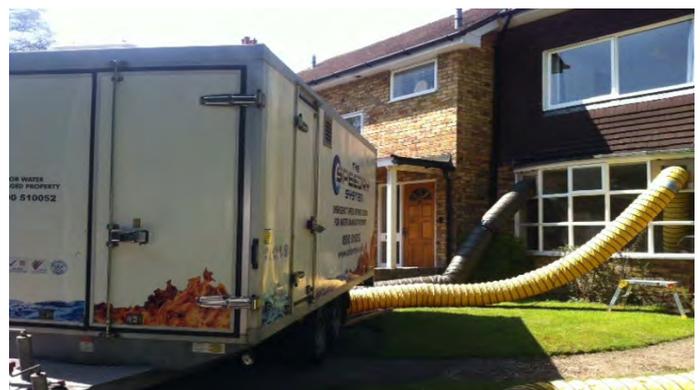
Above: speed drying trailer

Speed drying systems are typically mobile trailer units designed to heat multiple rooms to over 60°C. As independent units they are not reliant on the existing heating or electrical system of the home. Whilst this may reduce electricity costs to the householder, and may also mean the process can start more quickly - saving subsequent damage from prolonged dampness - they use diesel or petrol generators for power. These emit particulates and carbon monoxide which contribute to poor local air quality and create noise. The main unit usually pumps heat to smaller heat exchangers throughout the home; which usually have a power rating of 10, 30 or 60kW (ISS Restoration, online). The power used by such systems is therefore considerable.

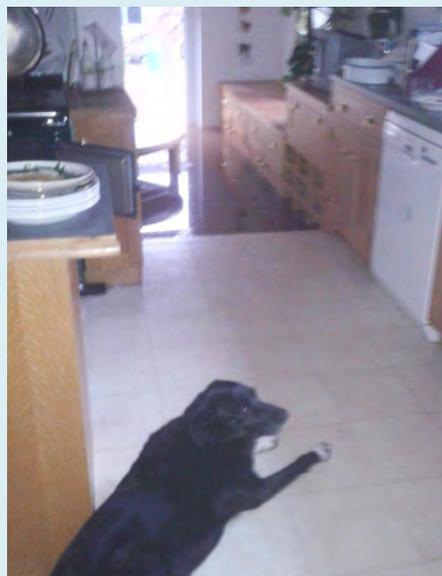
Left: The ground floor is on three levels which spared some items from damage.

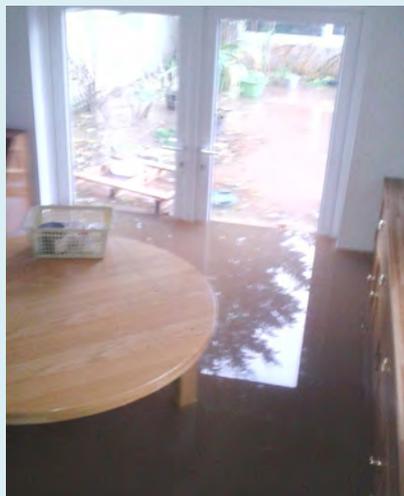
Right:
The flood water reached 1.3m at the rear of the house.

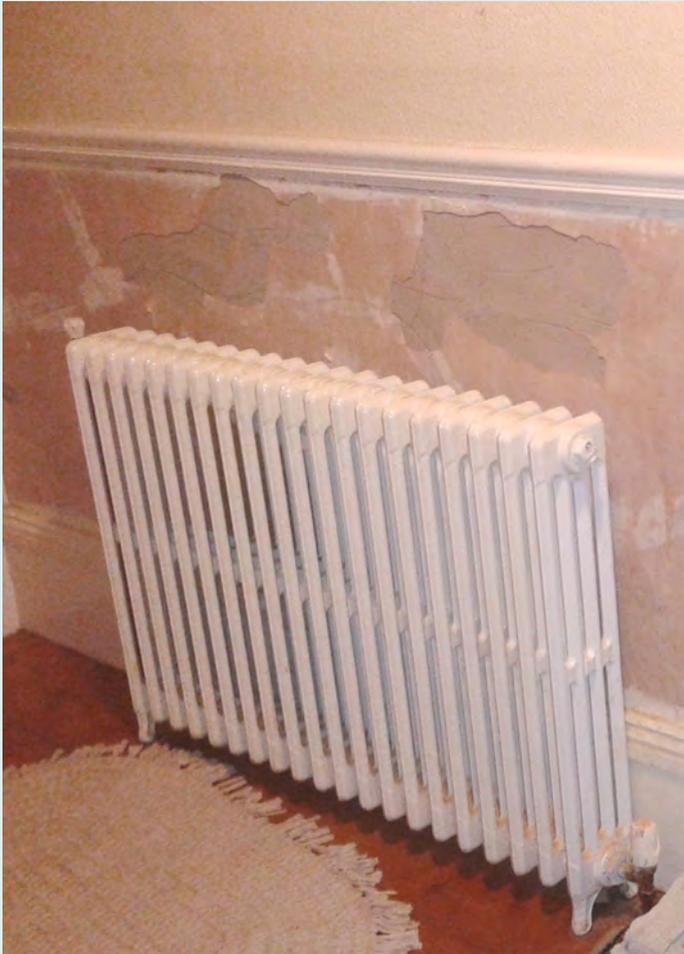
Some areas of skirtings, such as behind radiators, were not removed.

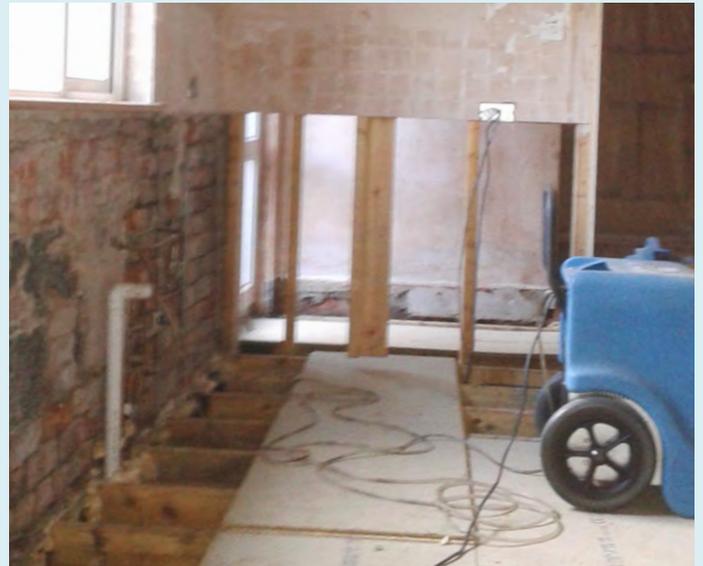
Drying out was by the gas central heating and dehumidifiers.

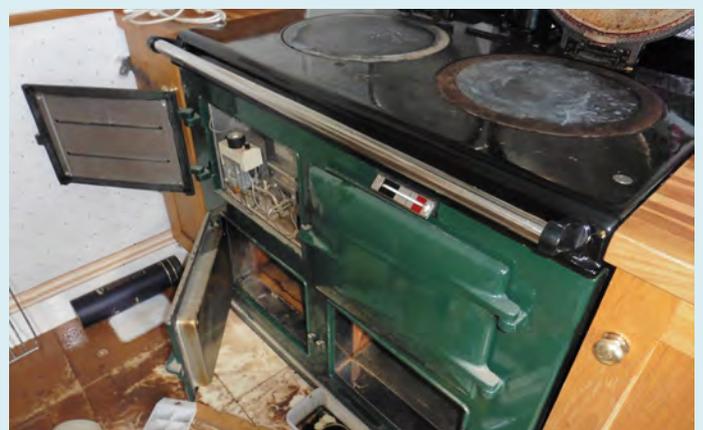
The AGA had to be replaced again after showing signs of rust.
